**Flood Control Project Maintenance  
Levee Inspections**  
**LMA District Cover Sheet**  
**Spring 2019 Levee Inspection Results**

**Levee District No. 0003 (Glenn County)**

**Spring 2019 Levee Inspection Results**

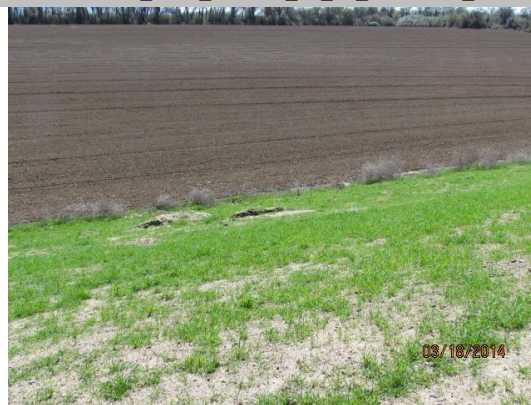
Photo 1 of 1 : SP\_2019\_LD0003\_27\_55\_20190319\_00026.jpg

View of the rodent activity along the waterside slope.

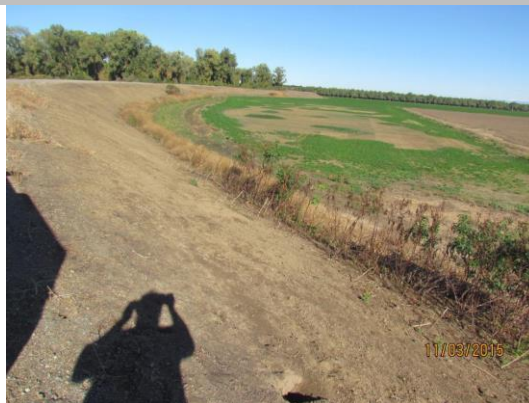
Photo 1 of 1 : SP\_2019\_LD0003\_27\_51\_20190319\_00023.jpg

View of the rodent holes along the landside slope.

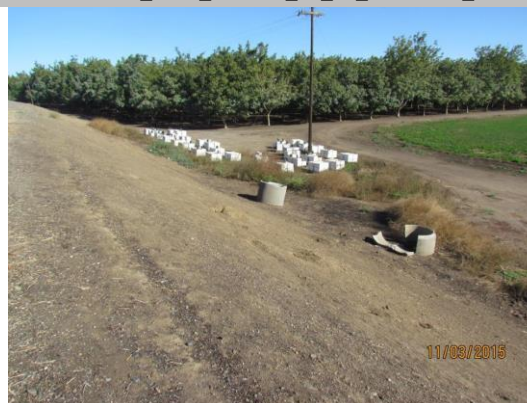
Photo 1 of 1 : SP\_2019\_LD0003\_27\_52\_20190319\_00024.jpg

View of the rodent holes along the landside slope.

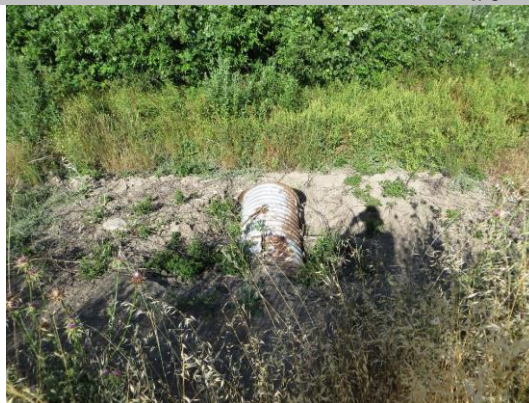
Photo 1 of 3 : UCIP\_SP\_2019\_14573\_24038.jpg

LM Start	1.47	Rating **	M	Issue No.	131
LM End	1.47	Issue Type +	En	Location *	
Category	Supplemental			GPS Latitude/Longitude	
				Start	End
Item	DWR UCIP Field Study			39.397780 °	39.397780 °
				-122.002074 °	-122.002074 °
DWR ID	18830				
Comment Code					
Inspector Comment					
FS_ID:14573 DS_ID:18830 EP_NO: 9930 Repair Type: Non-Urgent Crossing Status: Found UCIP Comments: Steel plate welded over WS end of pipe. Slide gate through the levee, 14.5 feet below the crown. Slide gate on waterside (WS) end. 7-foot by 9-foot concrete diversion box at landward toe (Automatic Board Order (ABO) issued as Permit No. 9930, 1974 - Steel Ranch). [Additional Reference(s): DWR Levee Log, 1992. USACE Sacramento O&M Manual 136, March 1960 (HLM 21.89)]. FS Date: 6/4/2013

24-inch CMP stormdrain on WS toe.

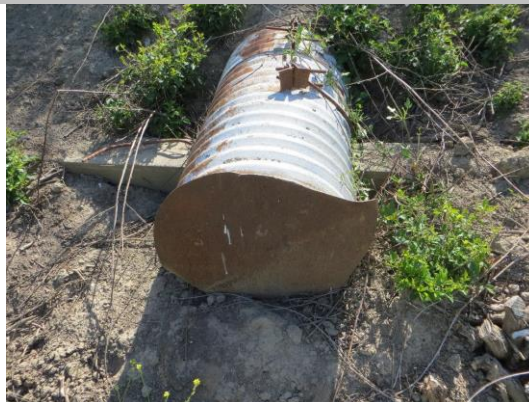
Photo 2 of 3 : UCIP\_SP\_2019\_14573\_24037.jpg

Steel plate welded over end of pipe on WS toe.

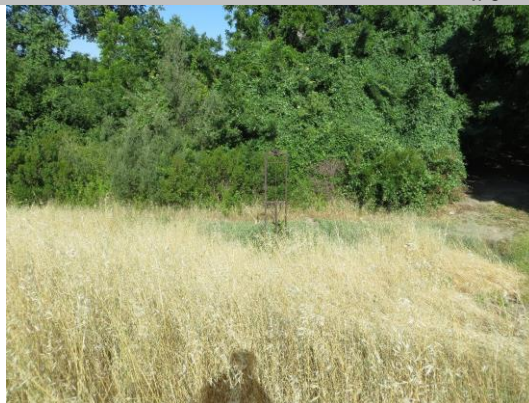
Photo 1 of 2 : UCIP\_SP\_2019\_14576\_24052.jpg

LM Start	1.58	Rating **	M	Issue No.	132
LM End	1.58	Issue Type +	En	Location *	
Category	Supplemental			GPS Latitude/Longitude	
				Start	End
Item	DWR UCIP Field Study			39.399330 °	39.399330 °
				-122.002402 °	-122.002402 °
DWR ID	18823				
Comment Code					
Inspector Comment					
FS_ID:14576 DS_ID:18823 EP_NO: 9931 Repair Type: Non-Urgent Crossing Status: Found UCIP Comments: Appears abandoned. Pipe burried at slide gate on WS toe. FIELD_STRUCT_DESC: 24-inch corrugated metal irrigation pipe through the levee, 15 feet below the crown. Slide gate on the waterside (WS) end. 6-foot by 7-foot concrete distribution box on the landside (LS) toe. (Automatic Board Order (ABO) issued as Permit No. 9931, 1974 - Lowell F. Steel). [Additional Reference(s): DWR Levee Log, 1992. USACE Sacramento O&M Manual 136, March 1960 (HLM 22.00)]. FS Date: 6/4/2013

Slide gate at WS toe.

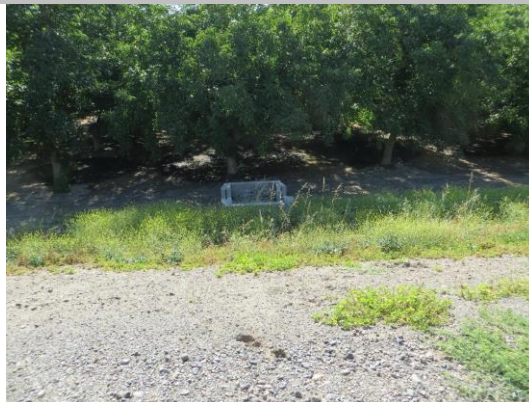
Photo 2 of 2 : UCIP\_SP\_2019\_14576\_24051.jpg

Concrete distribution box at LS toe.

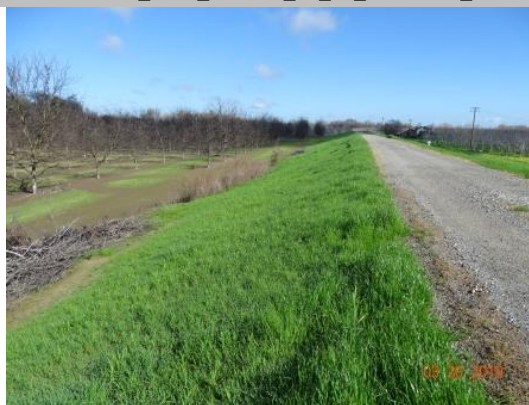
Photo 1 of 1 : SP\_2019\_LD0003\_27\_58\_20190322\_00101.jpg

View of the vegetation on the waterside slope, facing upstream.

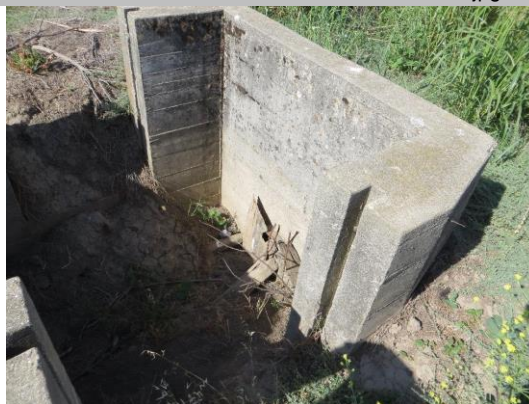
Photo 3 of 3 : UCIP\_SP\_2019\_14577\_24053.jpg

Debris and steel plate blocking inlet on LS toe.

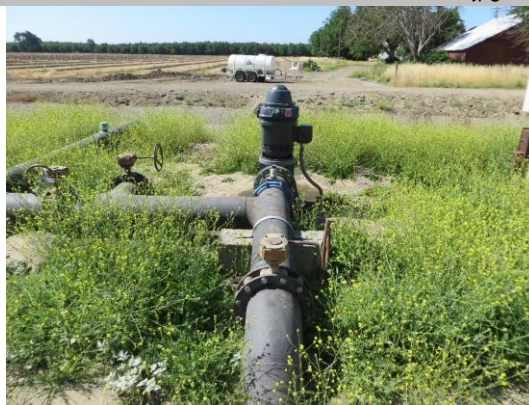
Photo 2 of 3 : UCIP\_SP\_2019\_15144\_24882.jpg

Pump and butterfly valve off LS toe.

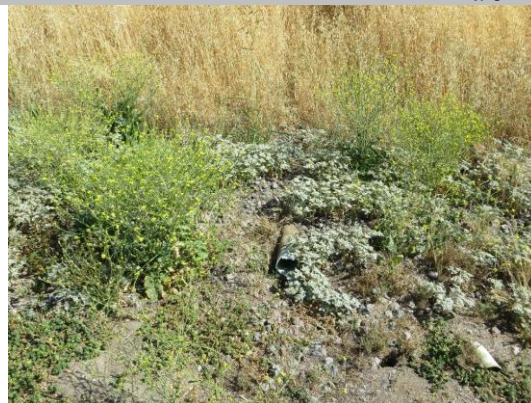
Photo 3 of 3 : UCIP\_SP\_2019\_15144\_24881.jpg

3-inch drain on WS toe (purpose unclear).

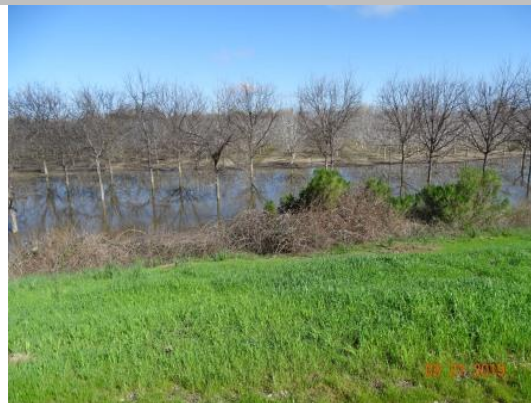
Photo 1 of 1 : SP\_2019\_LD0003\_27\_59\_20190322\_00102.jpg

View of the wild growth along the waterside slope and toe, facing north.  
(Spring 2019)

LM Start	2.16	Rating **	M	Issue No.	59
LM End	2.16	Issue Type +	Ma	Location *	WS
Category	Earthen Levee			GPS Latitude/Longitude	
				Start	End
Item	Vegetation			39.406443 °	39.406443 °
				-121.999634 °	-121.999634 °
DWR ID	DWR_LD0003_01_s_2019_59				
Comment Code					
V2 : Remove the wild growth other than native grasses from the levee slopes.					
Inspector Comment					
Clear brush from WS slope and toe.

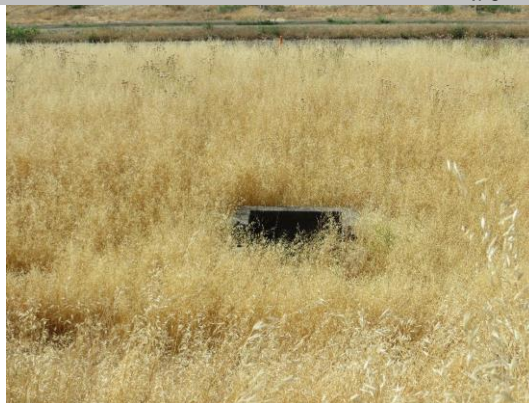
Photo 2 of 3 : UCIP\_SP\_2019\_14582\_24075.jpg

Comment Code						
Inspector Comment						
FS_ID:14582 DS_ID:18827 EP_NO: 9936 Repair Type: Non-Urgent Crossing Status: Found UCIP Comments: Appears abandoned. Pipe burried on WS and blocked with tin and soil on the LS. FIELD_STRUCT_DESC: 24-inch corrugated metal irrigation pipe through the levee, 18.3 feet below crown. Slide gate on the waterside (WS) end. 5-foot by 7-foot concrete distribution box at the landside (LS) toe. (Automatic Board Order (ABO) issued as Permit No. 9936, 1974 - J. A. and Florence Watt). [Additional Reference(s): DWR Levee Log, 1992. USACE Sacramento O&M Manual 136, March 1960 (HLM 22.82)]. FS Date: 6/4/2013

Concrete distribution box on LS toe.

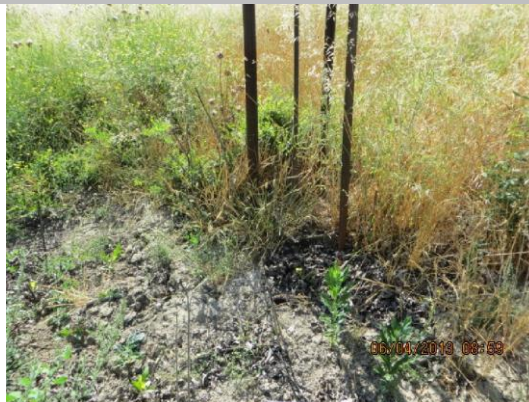
Photo 3 of 3 : UCIP\_SP\_2019\_14582\_24074.jpg

Slide gate at WS toe.

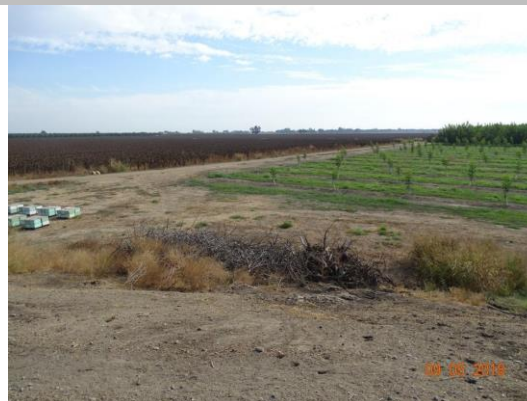
Photo 1 of 1 : SP\_2019\_LD0003\_27\_44\_20190319\_00021.jpg

View of the prunings along the landside toe.

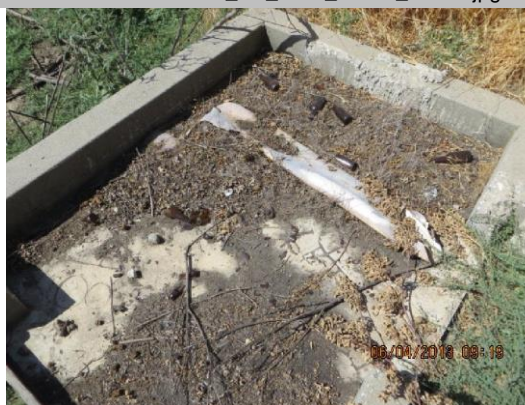
Photo 1 of 2 : UCIP\_SP\_2019\_14584\_24081.jpg

LM Start	2.98	Rating **	M	Issue No.	136
LM End	2.98	Issue Type +	En	Location *	
Category	Supplemental			GPS Latitude/Longitude	
				Start	End
Item	DWR UCIP Field Study			39.412827 °	39.412827 °
				-121.991427 °	-121.991427 °
DWR ID	18829				
Comment Code					
Inspector Comment					
FS_ID:14584 DS_ID:18829 EP_NO: 9919 Repair Type: Non-Urgent Crossing Status: Indicator Found UCIP Comments: Appears abandoned. Verify it was done corectly. FIELD_STRUCT_DESC: *ABANDONED* 24-inch corrugated metal irrigation pipe through the levee, 16 feet below the crown. Slide gate on the waterside (WS) end. 5-foot by 7-foot concrete distribution box at landside (LS) toe is filled with grout. (Automatic Board Order (ABO) issued as Permit No. 9919, 1974 - Roy and Annie Mills). [Additional Reference(s): DWR Levee Log, 1992. USACE Sacramento O&M Manual 136, March 1960 (HLM 23.43)]. FS Date: 6/4/2013

5'X7' concrete distribution box filled in with grout.

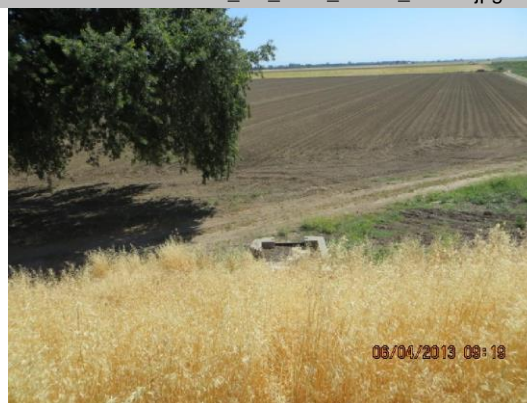
Photo 2 of 2 : UCIP\_SP\_2019\_14584\_24080.jpg

Comment Code						
Inspector Comment						
FS_ID:14584 DS_ID:18829 EP_NO: 9919 Repair Type: Non-Urgent Crossing Status: Indicator Found UCIP Comments: Appears abandoned. Verify it was done corectly. FIELD_STRUCT_DESC: *ABANDONED* 24-inch corrugated metal irrigation pipe through the levee, 16 feet below the crown. Slide gate on the waterside (WS) end. 5-foot by 7-foot concrete distribution box at landside (LS) toe is filled with grout. (Automatic Board Order (ABO) issued as Permit No. 9919, 1974 - Roy and Annie Mills). [Additional Reference(s): DWR Levee Log, 1992. USACE Sacramento O&M Manual 136, March 1960 (HLM 23.43)]. FS Date: 6/4/2013

Distribution box on LS toe.

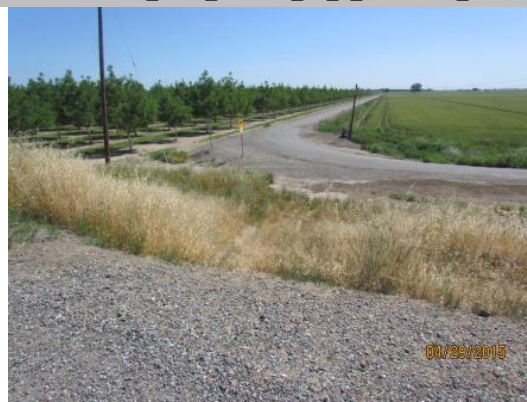
Photo 1 of 1 : SP\_2019\_LD0003\_27\_9\_20190319\_00006.jpg

View of the vehicle erosion along the landside slope.

LM Start	3.39	Rating **	M	Issue No.	9
LM End	3.39	Issue Type +	Ma	Location *	LS
Category	Earthen Levee			GPS Latitude/Longitude	
				Start	End
Item	Slope Stability			39.418382 °	39.418382 °
				-121.992480 °	-121.992480 °
DWR ID	DWR_LD0003_01_s_2012_9				
Comment Code					
S3 : Repair the levee slope damaged by vehicle traffic and prevent access where possible.					
Inspector Comment					
Repair the erosion along the landside slope and prevent vehicle access.

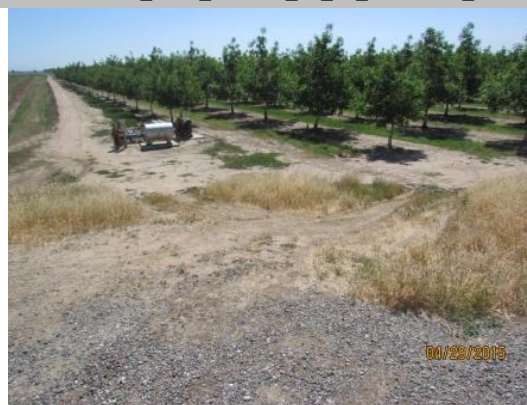
Photo 1 of 1 : SP\_2019\_LD0003\_27\_19\_20190319\_00010.jpg

View of the vehicle erosion along the landside slope.

LM Start	3.76	Rating **	M	Issue No.	19
LM End	3.76	Issue Type +	Ma	Location *	LS
Category	Earthen Levee			GPS Latitude/Longitude	
				Start	End
Item	Slope Stability			39.423747 °	39.423747 °
				-121.991667 °	-121.991667 °
DWR ID	DWR_LD0003_01_s_2012_19				
Comment Code					
S3 : Repair the levee slope damaged by vehicle traffic and prevent access where possible.					
Inspector Comment

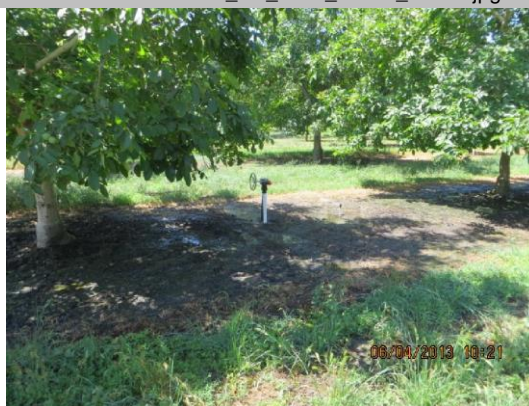
Photo 1 of 3 : UCIP\_SP\_2019\_15163\_24902.jpg

LM Start	4.96	Rating **	M	Issue No.	137
LM End	4.96	Issue Type +	En	Location *	
Category	Supplemental			GPS Latitude/Longitude	
				Start	End
Item	DWR UCIP Field Study			39.439791 °	39.439791 °
				-121.989825 °	-121.989825 °
DWR ID	23152				
Comment Code					
Inspector Comment					
FS_ID:15163 DS_ID:23152 EP_NO: N/A Repair Type: Non-Urgent Crossing Status: Found UCIP Comments: No permit identified for this crossing. FIELD_STRUCT_DESC: 4-inch steel irrigation pipe through the levee, at an unknown depth. Pump, vent, and shutoff valve off the landside (LS) toe. Possible shutoff valve off the waterside (WS) toe. FS Date: 6/4/2013

Possible shutoff valve on WS toe.

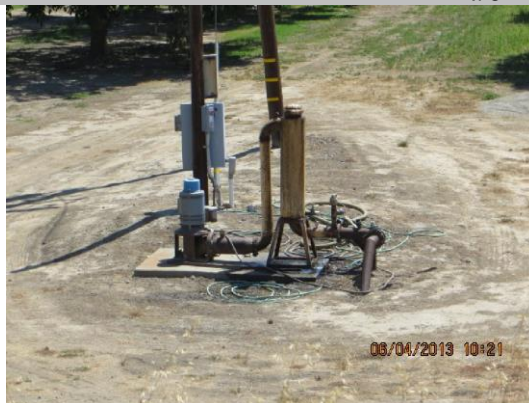
Photo 3 of 3 : UCIP\_SP\_2019\_15163\_24900.jpg

Pumping plant off LS toe.

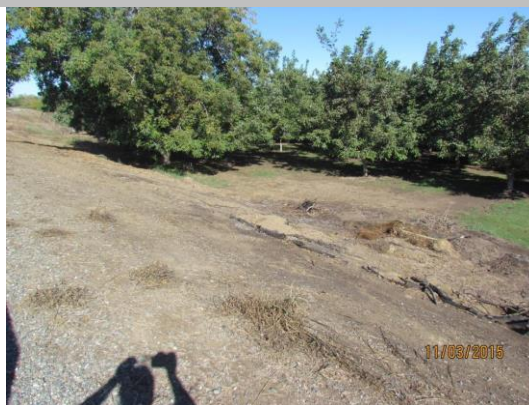
Photo 1 of 1 : SP\_2019\_LD0003\_27\_21\_20190319\_00011.jpg

View of the rodent holes along the landside slope.

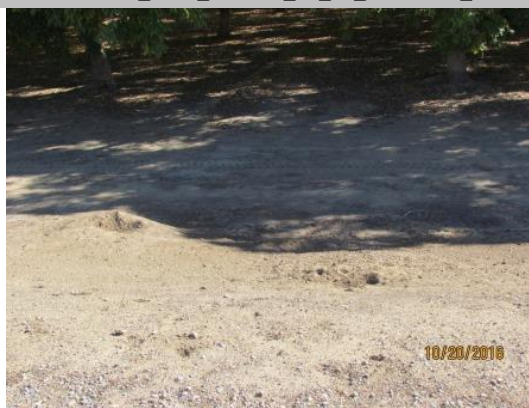
Photo 1 of 1 : SP\_2019\_LD0003\_27\_62\_20190319\_00029.jpg

View of the rodent holes along the landside slope.

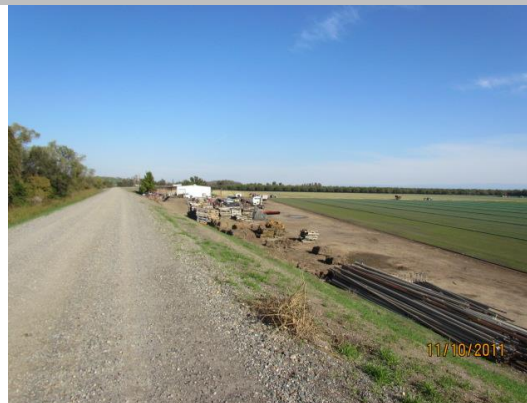
Photo 1 of 1 : SP\_2019\_LD0003\_27\_25\_20190319\_00012.jpg

View of the equipment along the landside toe.

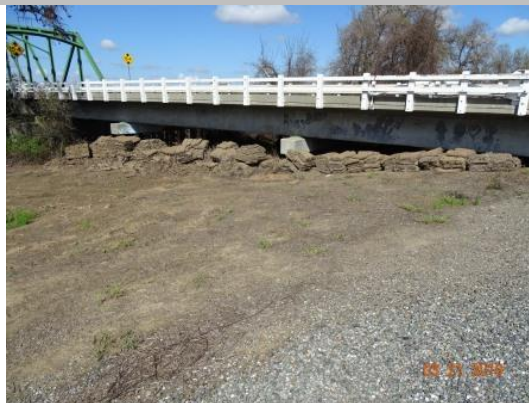
Photo 1 of 1 : SP\_2019\_LD0003\_27\_110\_20190322\_00106.jpg

View of the sod piles on the waterside slope within the floodway, facing upstream. (Spring 2019)

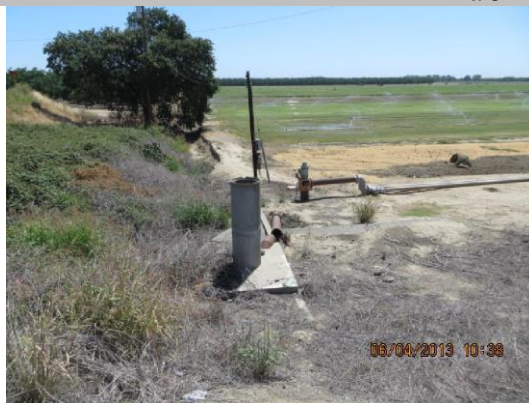
Photo 1 of 3 : UCIP\_SP\_2019\_14643\_24142.jpg

Concrete standpipe on LS toe.

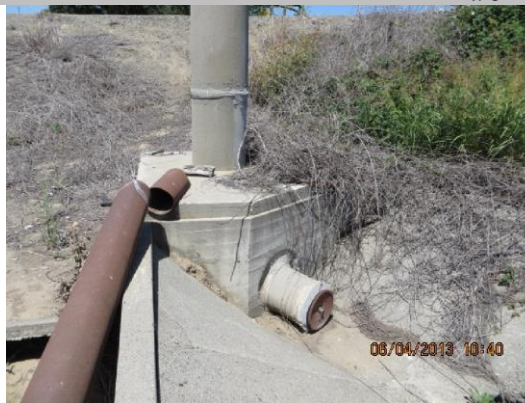
Photo 2 of 3 : UCIP\_SP\_2019\_14643\_24141.jpg

Concrete standpipe and channel on LS toe.

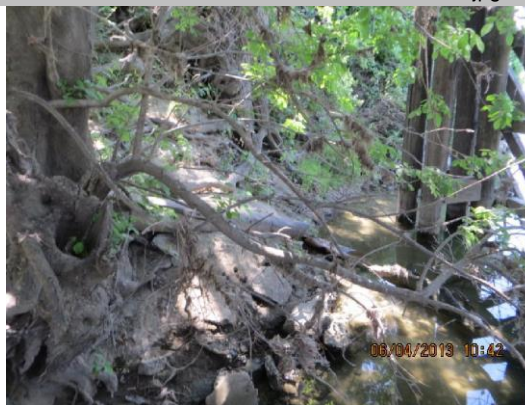
Photo 3 of 3 : UCIP\_SP\_2019\_14643\_24140.jpg

14-inch Pipe debris on WS toe.

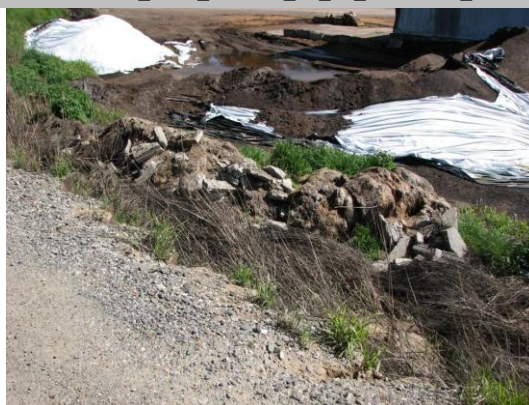
Photo 1 of 1 : SP\_2019\_LD0003\_27\_65\_20190319\_00032.jpg

View of concrete and soil obstructing visibility and access.

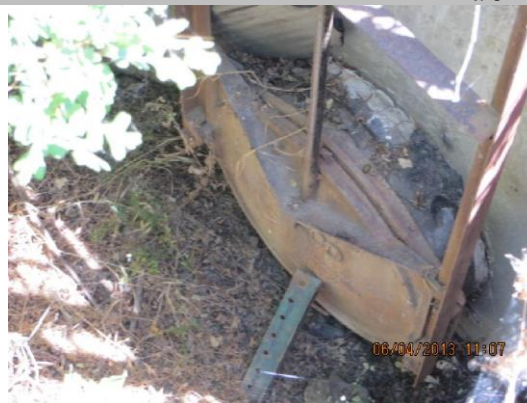
Photo 3 of 3 : UCIP\_SP\_2019\_14664\_24160.jpg

Slidegate inside concrete box on WS slope.

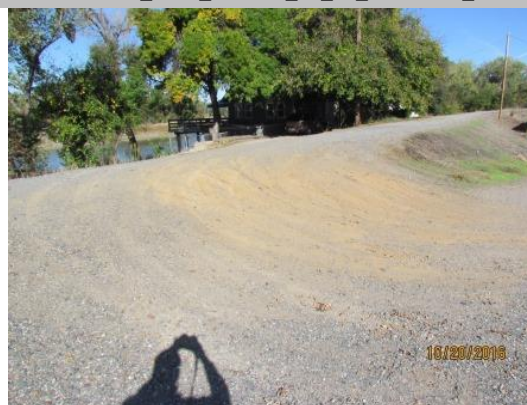
Photo 1 of 1 : SP\_2019\_LD0003\_27\_34\_20190319\_00015.jpg

View of slope instability caused by vehicle traffic.

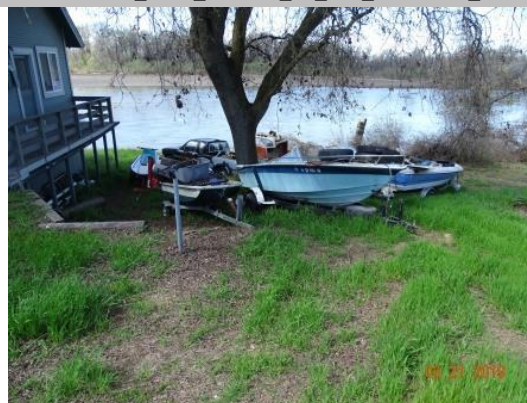
Photo 1 of 2 : SP\_2019\_LD0003\_27\_115\_20190322\_00103.jpg

Photo 1. View of the boats on the waterside slope and toe, facing west.

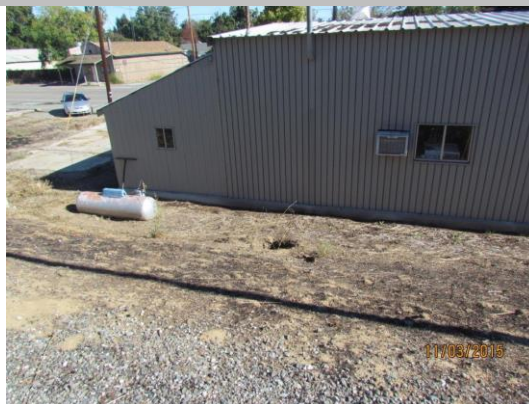
Photo 1 of 1 : SP\_2019\_LD0003\_27\_76\_20190319\_00042.jpg

View of the burned out stump hole along the landside toe.

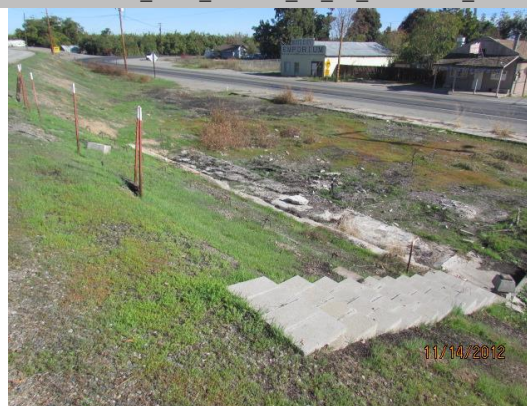
Photo 1 of 1 : SP\_2019\_LD0003\_27\_12\_20190319\_00007.jpg

View of concrete stairs & foundation along the slope of the levee.

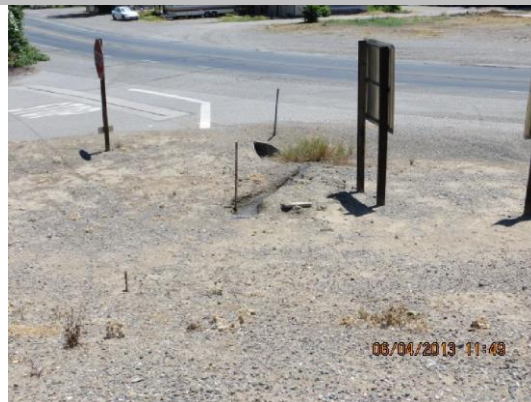
Photo 2 of 3 : UCIP\_SP\_2019\_15165\_24905.jpg

Pipe leaking at LS toe.

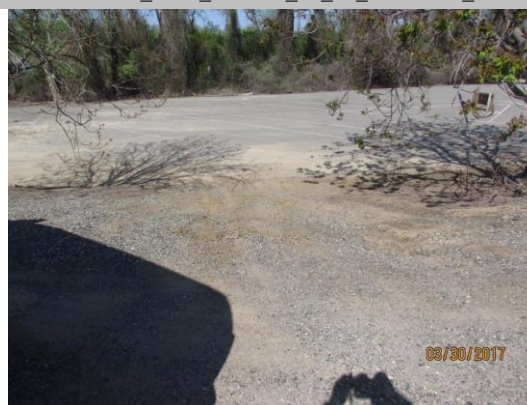
Photo 1 of 1 : SP\_2019\_LD0003\_27\_97\_20190319\_00054.jpg

View of the vehicle ruts on the waterside slope.

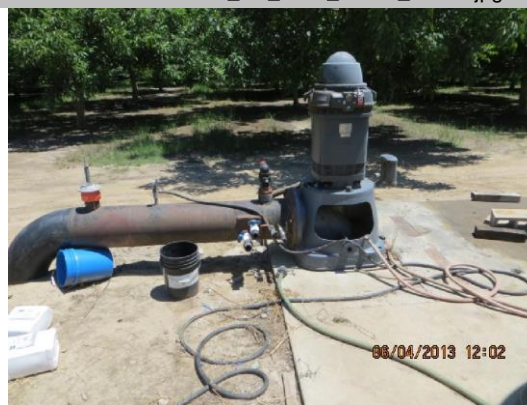
Photo 1 of 2 : UCIP\_SP\_2019\_14686\_24184.jpg

Pump located on LS toe next to concrete distribution box.

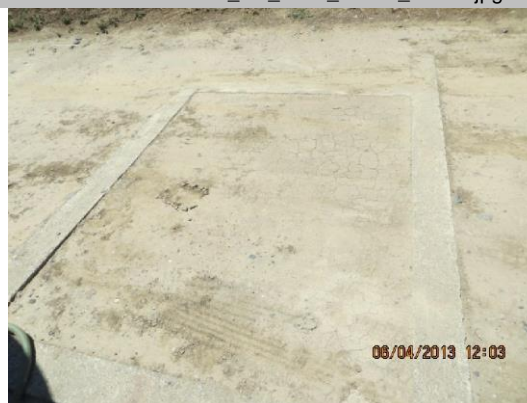
Photo 2 of 2 : UCIP\_SP\_2019\_14686\_24183.jpg

Soil filled concrete distribution box on LS toe.

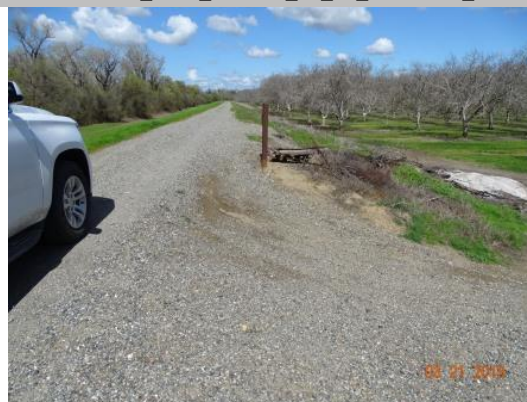
Photo 1 of 1 : SP\_2019\_LD0003\_27\_14\_20190322\_00105.jpg

View of the erosion caused by vehicle traffic along the landside slope and crown, facing upstream. (Spring 2019)

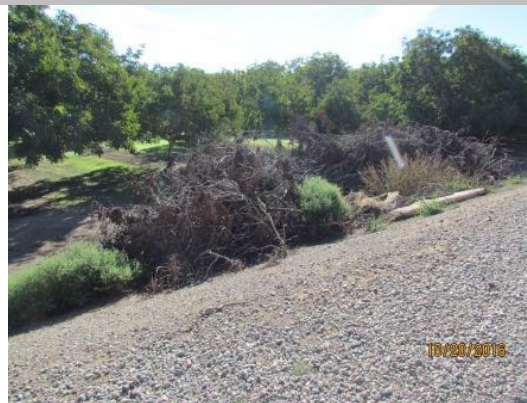
Photo 1 of 1 : SP\_2019\_LD0003\_27\_61\_20190319\_00028.jpg

View of the pruning along the landside toe.

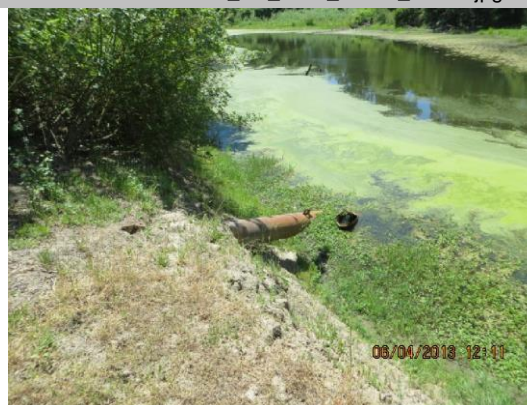
Photo 1 of 3 : UCIP\_SP\_2019\_14687\_24187.jpg

Pipe visible at pond off WS toe.

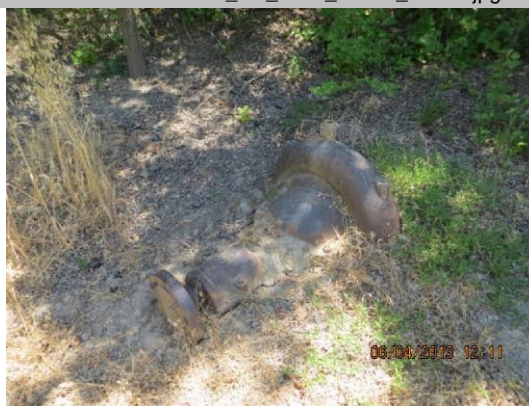
Photo 2 of 3 : UCIP\_SP\_2019\_14687\_24186.jpg

Pump visible off WS toe, next to pond.

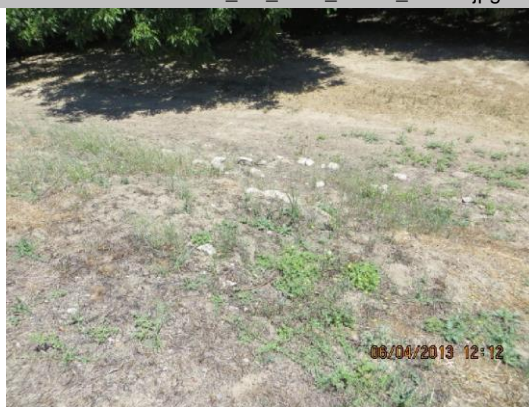
Photo 3 of 3 : UCIP\_SP\_2019\_14687\_24185.jpg

Remnants of concrete distribution box on LS toe.

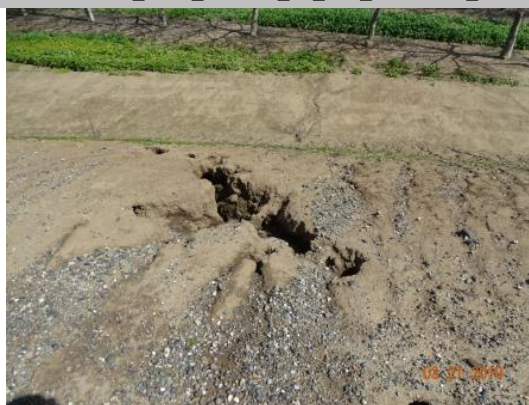
Photo 1 of 1 : SP\_2019\_LD0003\_27\_119\_20190322\_00108.jpg

View of the erosion caused by water runoff and rodent holes on the landside slope, facing east. (Spring 2019)

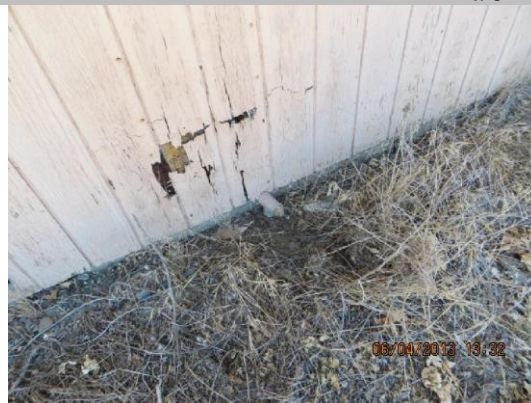
Photo 1 of 3 : UCIP\_SP\_2019\_14688\_24190.jpg

Pipe at side of building on WS shoulder.

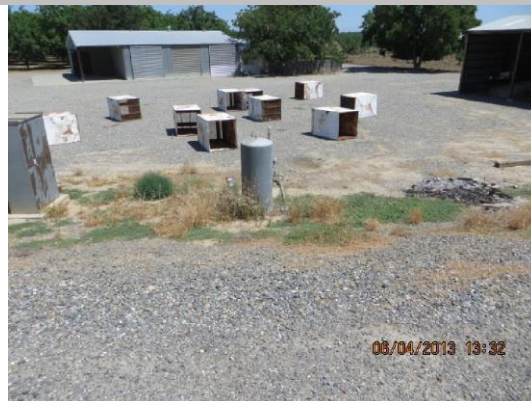
Photo 2 of 3 : UCIP\_SP\_2019\_14688\_24189.jpg

Water tank, pump, and well head on LS toe.

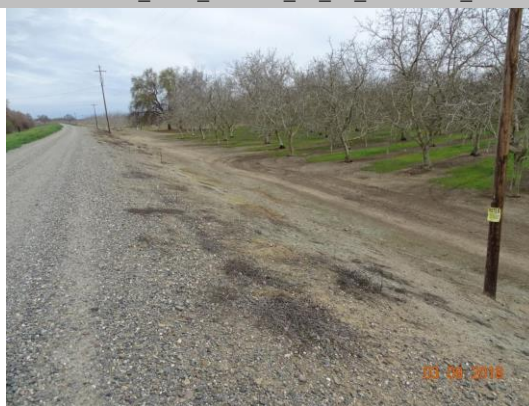
Photo 1 of 1 : SP\_2019\_LD0003\_27\_78\_20190319\_00044.jpg

View of the rodent holes along the landside slope.

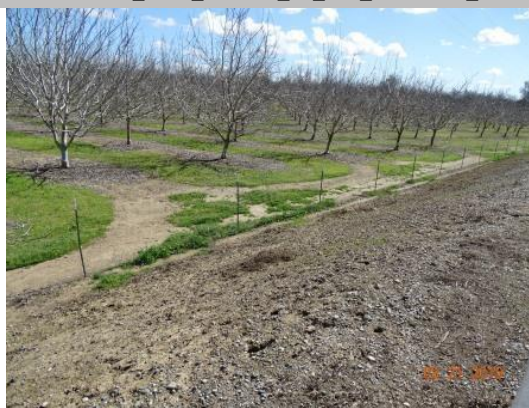
Photo 1 of 1 : SP\_2019\_LD0003\_27\_125\_20190322\_00111.jpg

View of the rodent holes along the landside slope, facing downstream.  
(Spring 2019)

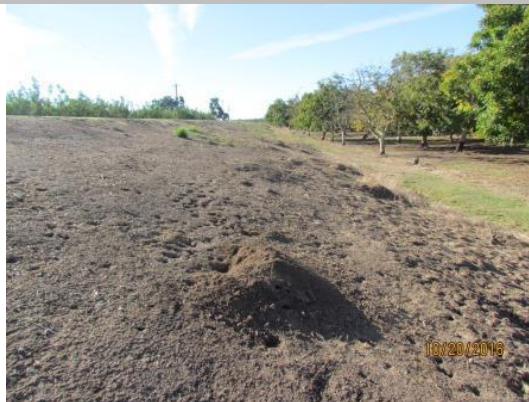
Photo 1 of 1 : SP\_2019\_LD0003\_27\_93\_20190319\_00050.jpg

View of the rodent holes along the waterside slope.

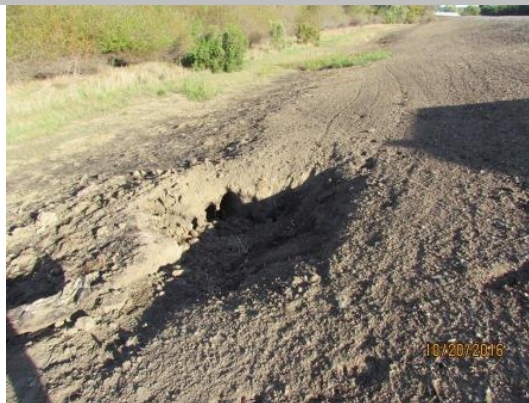
Photo 1 of 1 : SP\_2019\_LD0003\_27\_89\_20190319\_00049.jpg

View of a hole along the waterside slope that need to be backfilled and compacted.

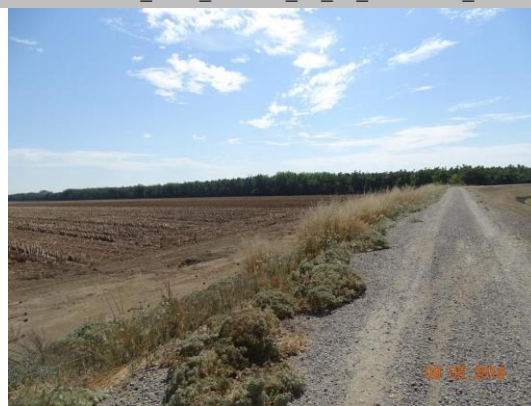
Photo 1 of 1 : SP\_2019\_LD0003\_27\_81\_20190319\_00046.jpg

View of the vegetation along the landside slope.

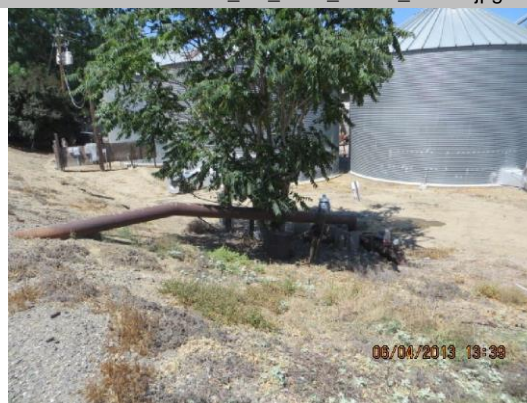
Photo 1 of 3 : UCIP\_SP\_2019\_14690\_24193.jpg

10-inch pipe and pump on LS.

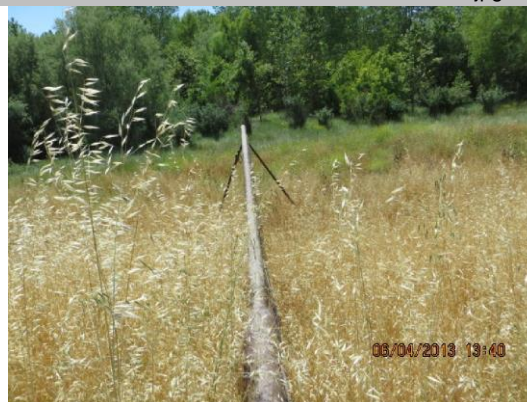
Photo 2 of 3 : UCIP\_SP\_2019\_14690\_24192.jpg

Pipe on WS shoulder.

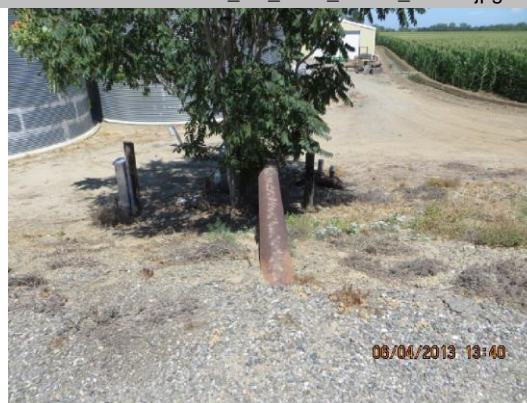
Photo 3 of 3 : UCIP\_SP\_2019\_14690\_24191.jpg

10-inch pipe on LS.

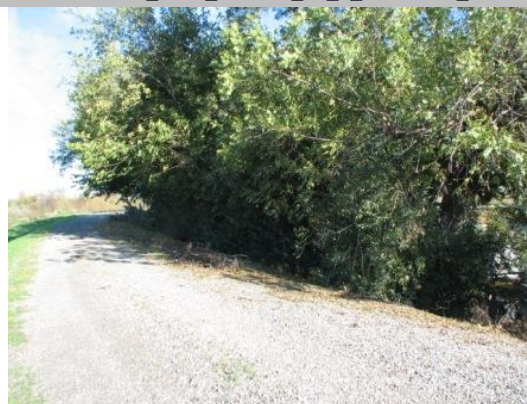
Photo 1 of 1 : SP\_2019\_LD0003\_27\_4\_20190319\_00002.jpg

View of the trees along the landside slope.

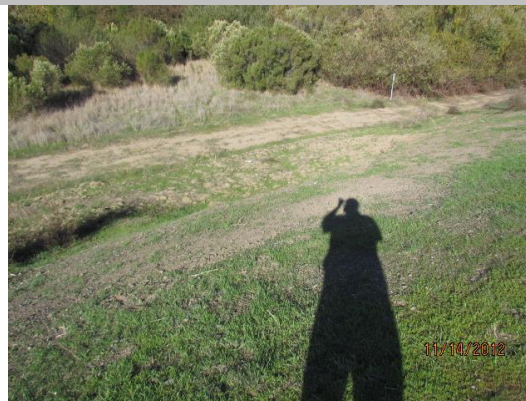
Photo 1 of 1 : SP\_2019\_LD0003\_27\_6\_20190319\_00004.jpg

View of the vertical cut along the waterside toe.

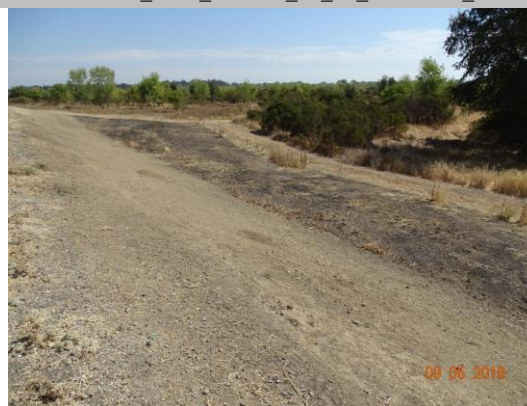
Photo 1 of 1 : SP\_2019\_LD0003\_27\_79\_20190319\_00045.jpg

View of the rodent holes along the landside slope.
